DEPARTMENT OF TRANSPORTATION**DIVISION OF ENGINEERING SERVICES**

Contract #: 04-0120F4Cty: SF/ALA Rte: 80 PM: 13.2/13.9File #: 1.28**WELDING INSPECTION REPORT****Resident Engineer:** Casey, William**Address:** 333 Burma Road**City:** Oakland, CA 94607**Report No:** WIR-028278**Date Inspected:** 27-Aug-2012**Project Name:** SAS Superstructure**OSM Arrival Time:** 700**Prime Contractor:** American Bridge/Fluor Enterprises, a JV**OSM Departure Time:** 1930**Contractor:** American Bridge/Fluor Enterprises, a JV**Location:** Job Site**CWI Name:** As noted below.**CWI Present:** Yes No**Inspected CWI report:** Yes No N/A**Rod Oven in Use:** Yes No N/A**Electrode to specification:** Yes No N/A**Weld Procedures Followed:** Yes No N/A**Qualified Welders:** Yes No N/A**Verified Joint Fit-up:** Yes No N/A**Approved Drawings:** Yes No N/A**Approved WPS:** Yes No N/A**Delayed / Cancelled:** Yes No N/A**Bridge No:** 34-0006**Component:** Tower**Summary of Items Observed:**

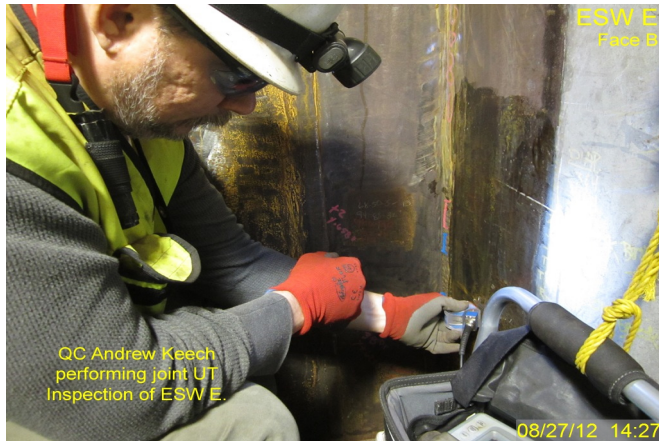
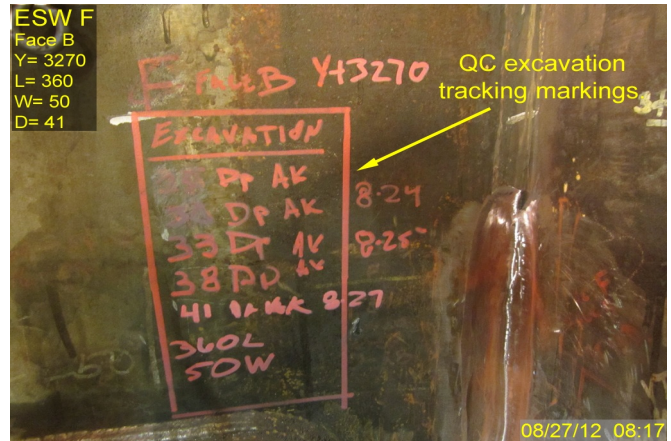
This QA observed ABF/JV welding personnel James Zhang #6001 continued performing excavation of an Electroslag Weld (ESW) repair previously Magnetic Particle Tested (MT) by Quality Control (QC) technicians.

The MT discovered indication was found to be oriented in the longitudinal position along the toe of the repair weld.

The weld being excavated is designated as "ESW F" and was excavated on Face B at location:

Weld "F" – Y= 3270mm, L= 360mm, W= 50mm, 41mm.

The carbon arc gouging process, as well as machine grinding, are being used to excavate this weld. At random intervals both QA and QC performed Magnetic Particle Testing (MT) to determine if the rejectable indication had been removed.

This QA randomly observed ABF/JV qualified welder Xiao Hua Lu #1291 performing Shielded Metal Arc Welding (SMAW) with 3.2mm" diameter E7018H4R electrode and implementing Caltrans approved Welding Procedure Specification's (WPS) ABF-WPS-D15-1000-R. The joint being welded was tower shear plate designated as ESW weld, location "F" from face B.
